# Data Analysis and Troubleshooting Guide

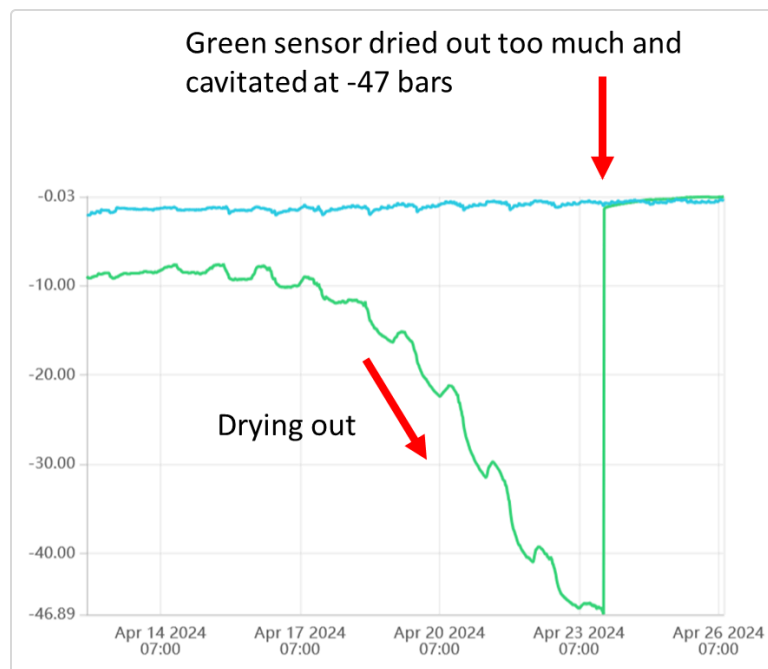
## Sensor suddenly goes to zero and stays there. Cavitation.

- Sensor dried out to below -35 bars, then suddenly jumped to zero and is stuck at zero.

- The sensor cavitates. Cavitation happens when the WP drops too low and the sensor membrane cannot hold the tension. The water inside the probe 'breaks' and the sensor will suddenly read zero.
- All sensors are tested during manufacture to ensure they will not cavitate above (wetter than) -35 bars.
- A sensor can also cavitate above (wetter) than -35 bars due to a defect in the membrane (the membrane broke).

- Refilling the sensor may bring it back to life. If plan to refill, keep sensor wet in the meantime. Our distributor Lab-Ferrer in Spain offers refilling services to his clients.

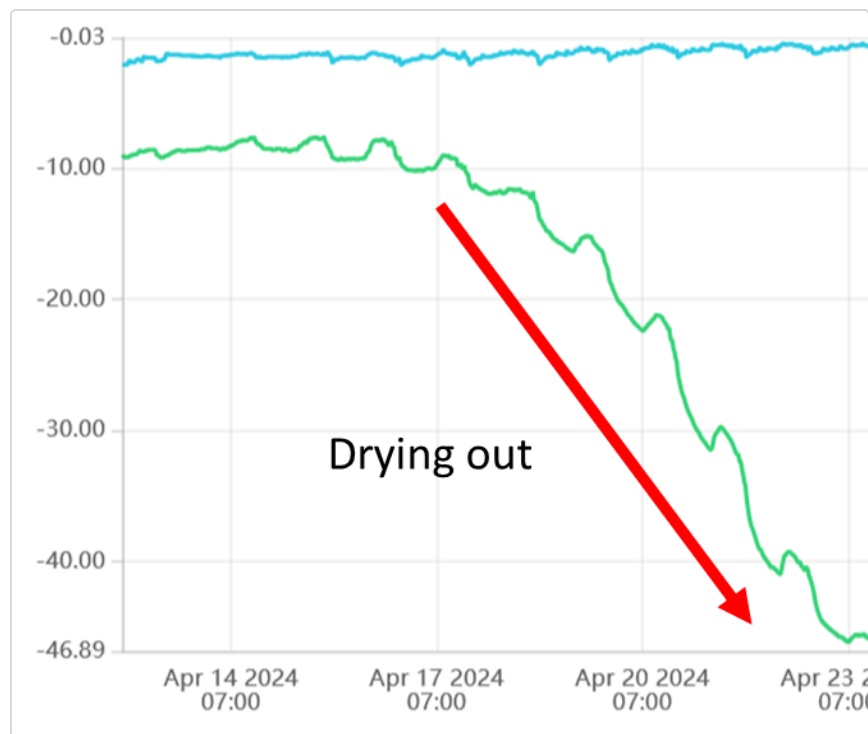
## Sensor dries out over time, unreasonably low SWP

- Measured SWP slowly drops over the course of days to values that are too dry. Both predawn and midday SWP are too low.

- The sensor installation site is drying out. This is likely due to a water vapor leak from somewhere in the installation site. The water seal is faulty.

- Try adding more sealant around the sensor sleeve to block any leaks.
- Try removing and reinstalling the sensor in a new spot.

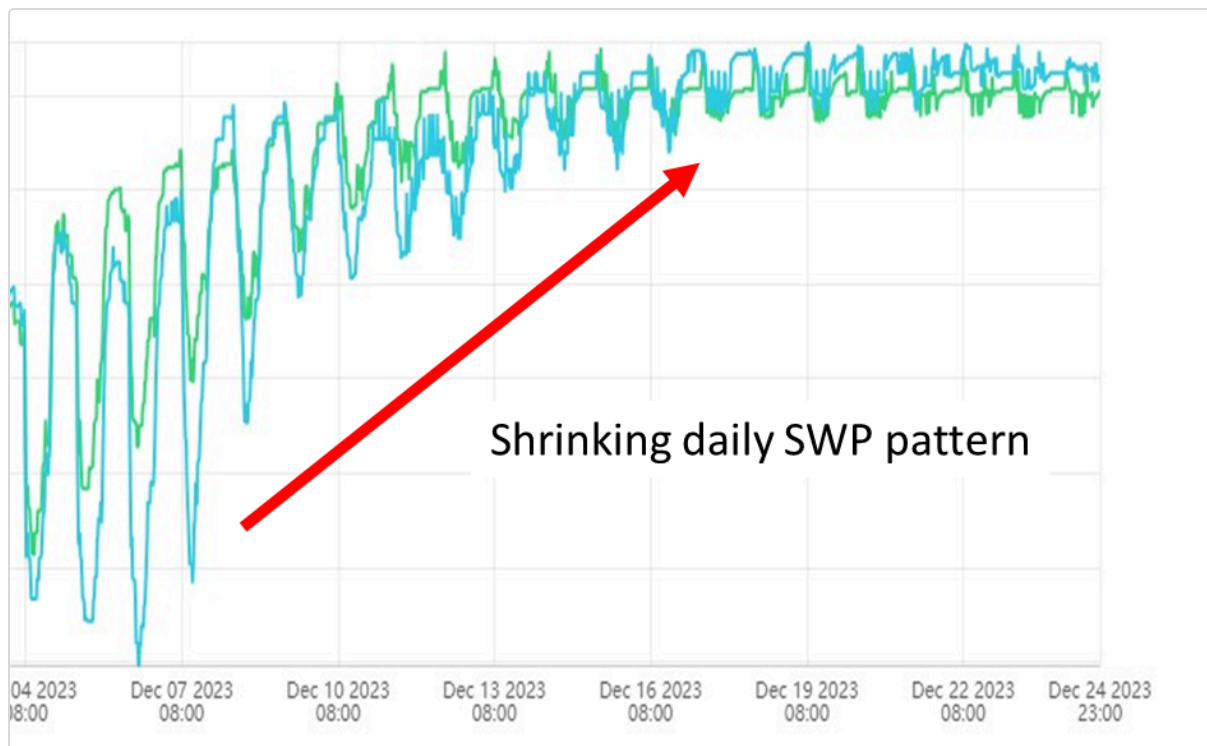
## Sensor diurnal SWP fluctuations shrink. Difference between highest and lowest daily SWP become too small.

- Sensor SWP readings show a shrinking diurnal pattern that may or may not go to zero.

- Poor connection with xylem due to wounding response.
- Poor connection with xylem because installation wound closed over time.

- This behavior may be due to the specific crop (i.e. walnut does this every time). Try re-installing and seeing if it happens again.
- Sensor may also be installed in 'dying' area of xylem. Reinstall in a different site.
- This behavior is normal and not a problem during the winter when the tree stops transpiring.

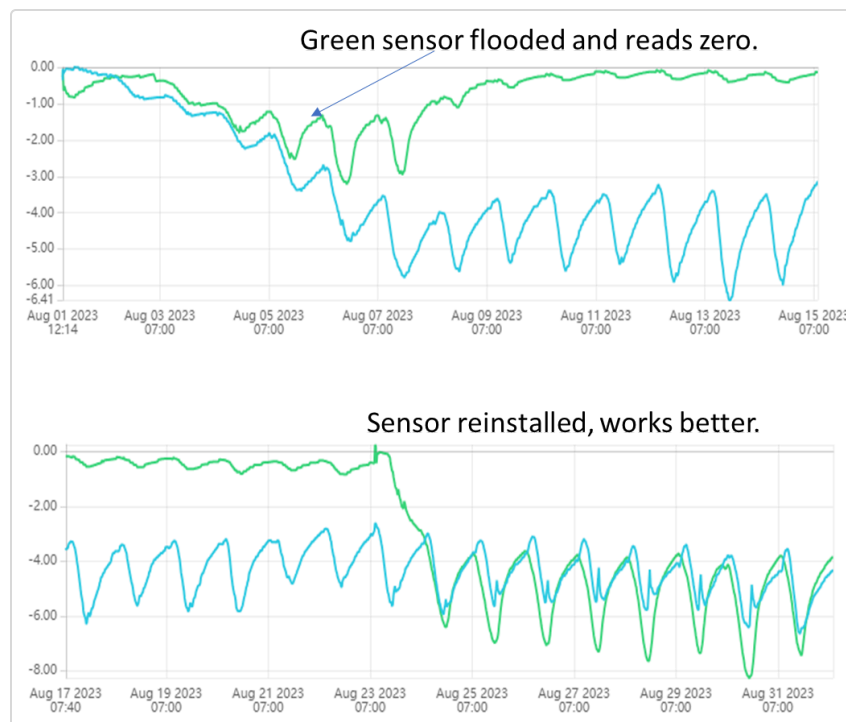
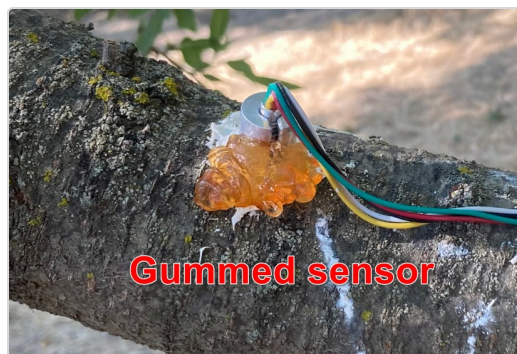
## Sensor slowly goes to zero and stays there. Flooded.

- The sensor slowly goes to zero and stays there.

- Wounding response is blocking sensor.
- Sensor installed in 'dead zone' of xylem.

- Try re-installing sensor.
- Some crops flood sensor immediately and cannot be measured for long: pecan, walnut and avocado.
- Some crops flood sensor randomly: pistachio, some citrus.
- Almond/prunus gumming can sometimes get into the sensor installation site.

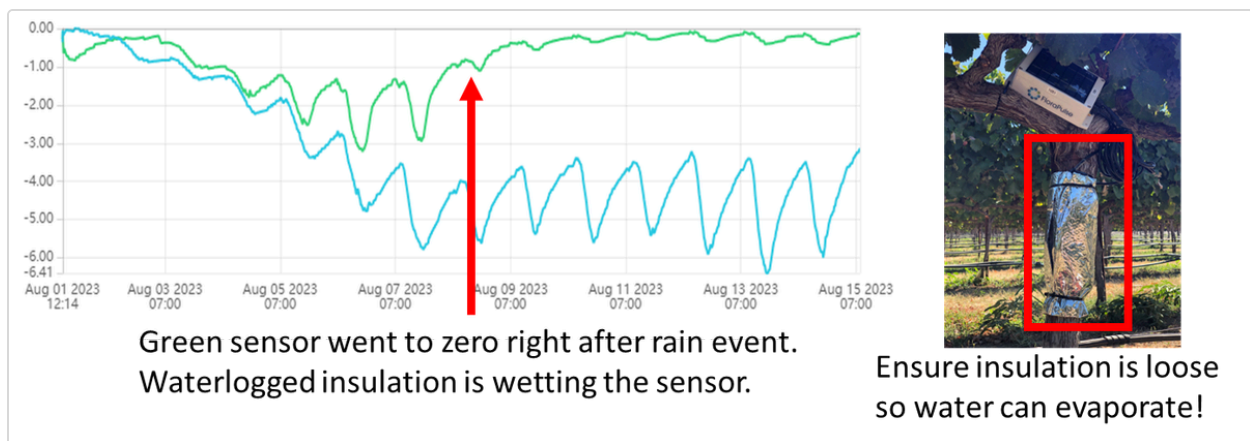
## Sensor goes to zero right after a rain event. Waterlogged insulation causes sensor to read too wet.

- Sensor displays similar behavior to sensor flooding. The sensor goes to zero and stays there, but this happens right after a rain/wetting event. It can also happen when there is morning dew.

- Water stuck inside the insulation is wetting the trunk for multiple days and getting to the sensor install site. This external water causes the sensor to read too wet.

- The sensor bubble wrap insulation should be attached somewhat loosely so that excess moisture can evaporate. This is especially important in wet climates.
- You might need to ignore SWP data right after a big rain storm, until excess water dries out.
- New small probe is less affected by outside rain due to use of better sealant.

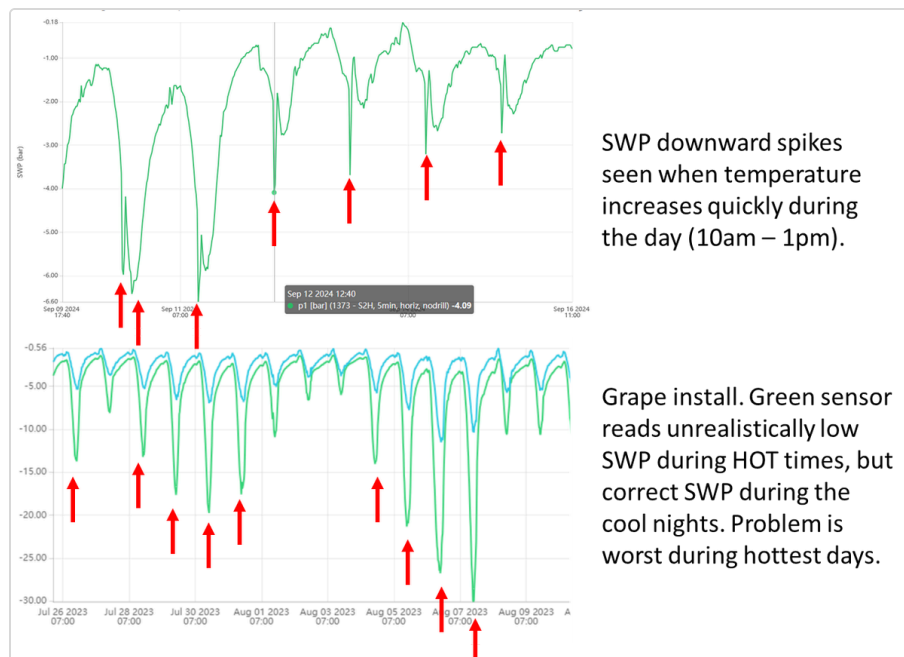
## Unrealistically dry readings during the hottest parts of the day, or quick drops in SWP during temperature increases (i.e. 10am). Psychometric.

- Reading WP is extremely difficult because tiny temperature differences cause huge errors. This is usually not a problem with FloraPulse, except when there's an air gap between sensor and xylem. For accurate measurement, there needs to be a continuous water path between the sensor and xylem.
- In the field, this shows up as reasonable SWP values when temperature isn't changing much (at night), but very negative SWP measurements during the midday. The problem is worst during the hottest days.
- We call these spikes a 'psychometric effect' because they are caused by differences in temperature when the sensor-xylem hydraulic connection is poor.

- Random air bubbles in the mating compound.
- Lots of cavitation in the mating compound due to very high, sustained heat and dry SWP.
- Break in the mating compound because the sensor was moved/hit, or subjected to vibrations.
- Installation into cavitated xylem vessels. This can happen if the install site is left to dry before sensor installation, or due to the specifics of your crop's xylem.

- It's exceedingly difficult to diagnose exactly why this problem happens in a particular installation.
- Adding a big amount of air-tight insulation may help. But extra insulation is bulky and can absorb water during rain events (or condensation) and create the opposite problem.
- Usually it's best to reinstall the sensor – this should fix the problem.

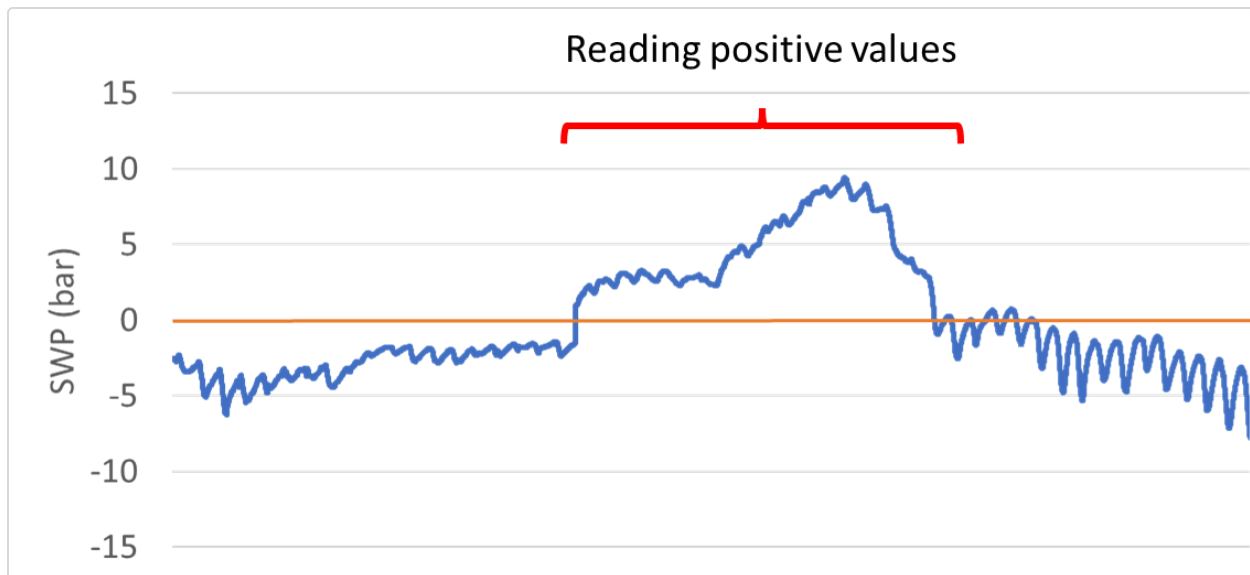
## Sensor reads positive values over 1 bar

- Sensor reads unrealistically positive values, often happens right after a rain event.

- Pressure on the chip can cause it to read positive values temporarily. This often happens right after a rain event when the xylem expands with water and presses on the chip.

- Recommend ignoring the data if it is temporary. Otherwise remove and reinstall the sensor. You may also test the sensor in the lab to ensure it reads zero in water.
- Some species produce xylem exudates that press on the sensor and impede accurate measurement. If you consistently get positive readings in a particular species, the microtensiometer may just be incompatible and you'll need to use a different method to measure SWP.

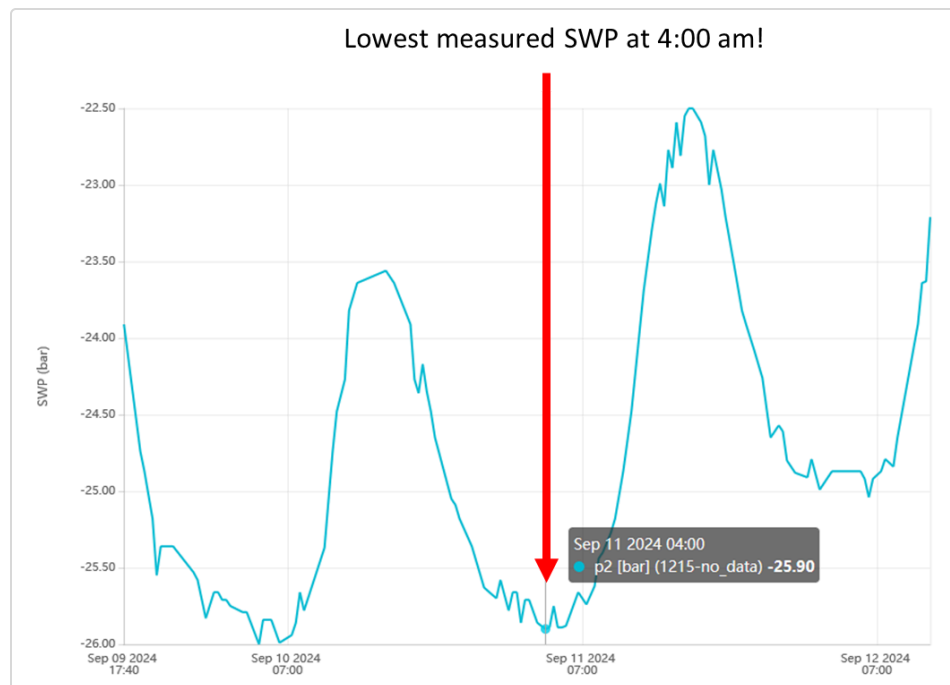
## The lowest SWP for the day is delayed and happens at nighttime (i.e. 2 am)

- Measured SWP usually reads lowest during the hottest part of the day, around 2 – 6 pm. But in this particular installation, the sensors read lowest anywhere between 8 pm to 8 am. This does not make sense.
- Usually this problem happens gradually. The sensors initially reach minimum SWP at 3 pm, but over time this time shifts to 6 pm, the 9 pm, and eventually 2 am.

- We are currently not sure exactly why this delay happens, but believe it to be related to the wounding response. When osmolyte-full wounding gels make contact with the installation site, this generally happens. The physics of how and why this happens are unclear.

- Sensors with a delayed response should be removed and reinstalled. This usually fixes the issue.
- The new small sensors are less likely to have this issue because of the way they are installed. The new installation method uses a better sealant to prevent wounding exudate infiltration into the install site.

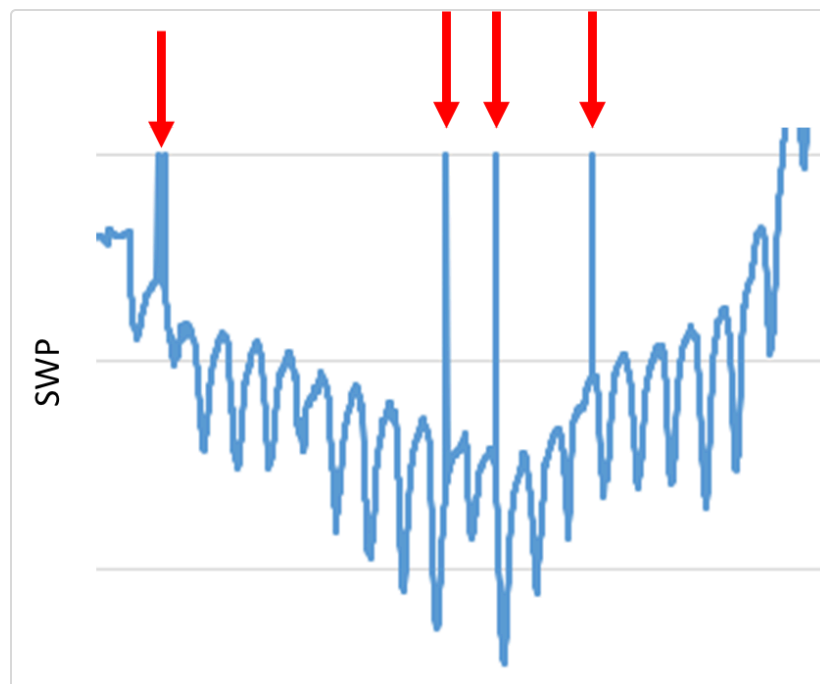
## Random upward spikes/noise

- Sensors sometimes show random 'upward' spikes in the reading.

- It's unclear what causes this, but it may be due to the tree pressing on the sensor and stressing the chip.

- Recommend just ignoring them.
- The new smaller probe may be less susceptible because the probe sits completely inside the sleeve and isn't pressed on by the tree.

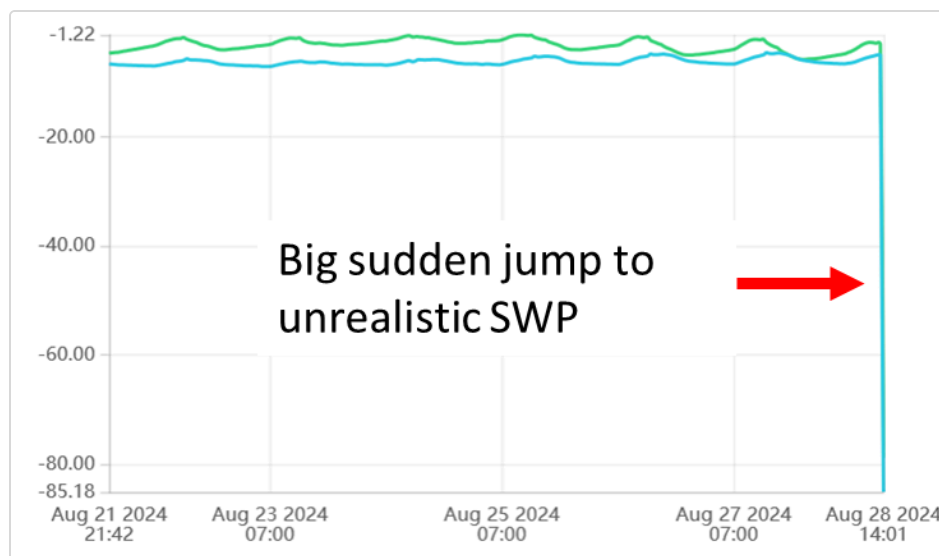
## SWP data suddenly jumps to unrealistic value, or shows big 5+ bar amounts of noise. Sensor breaks.

- Measured SWP suddenly jumps to an unrealistic value, or show big 5+ bar noise.
  - SDI12 interface: measured voltage will usually go to +31.25 mV or -31.25 mV
  - Analog sensors: measured voltage will go to a very high/low value.

- It's usually obvious when a sensor outright breaks. The data will have a huge jump in SWP and become noisy.
- The sensor may break due to mechanical damage to the wires from rodents, other critters or machines.
- It may also break due to excess pressure on the chip, usually due to a strong wound response. When this happens, the tree fills the installation site with gels and increases the pressure inside the installation sleeve. The increased pressure can move the chip and break the solder joints that attach it to the measurement wires.

- Unfortunately sensors cannot be repaired because the parts are so small. A sensor replacement is needed. If the sensor is under warranty, we will replace it!
- Please be careful when testing our sensors in new species, as the wounding response may break them. We recommend testing 1 or 2 sensors to start, to avoid the frustration of breaking many sensors right away.
- Tie up wires to the tree after installation to keep them away from the path of humans or machines.

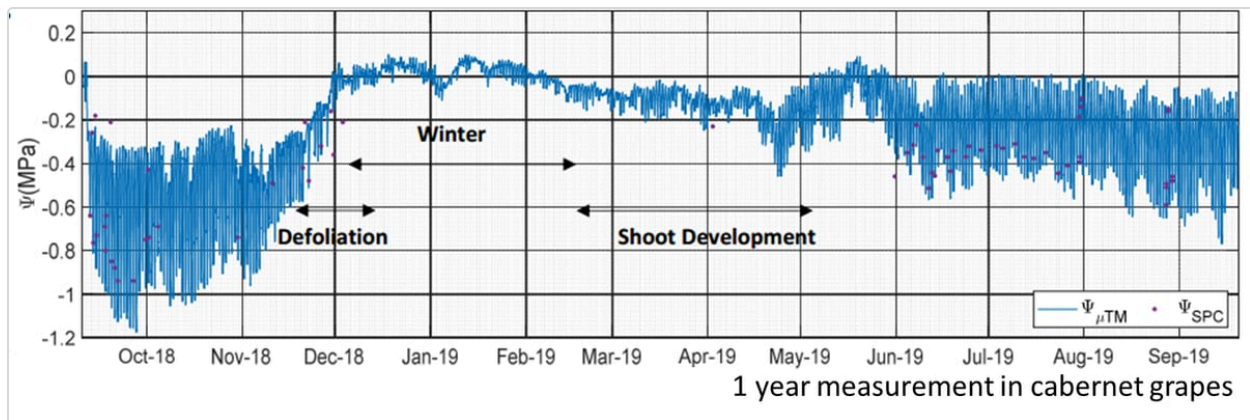
## Over-winter behavior

- Many crops go dormant during the winter and the measured water potential will go to zero, or show some 'noise' near zero.
- Measured water potential may go slightly above zero (+1 or +2 bars max).

- This is normal and expected behavior. Trees will usually measure zero during dormancy.

- Data during dormancy is not particularly useful and may be dominated by noise. We recommend ignoring data during winter, and not placing much emphasis on patterns seen during this time.
- We recommend sensors be removed and re-installed after winter for best accuracy. Depending on the crop, the installation wound closes during the winter, and if the sensors are not re-installed, they will read overly-wet values.

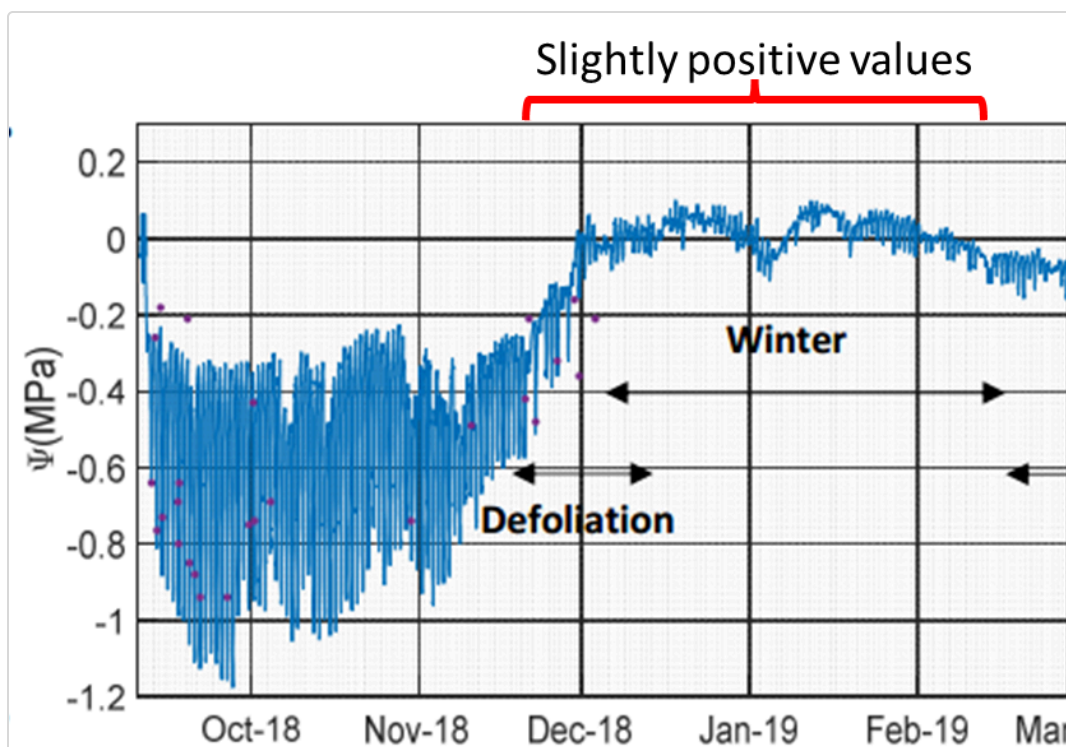
## Slightly positive SWP values

- Sensors read values slightly above zero.

- Electrical noise (sensor inaccuracy).
- In some crops, there is actually positive pressure in the xylem at times (i.e. grape during leaf out) and the sensor is reading this.
- The solutes from the tree xylem/elsewhere got into the sensor water and cause readings above zero due to osmotic pressure.

- Sensor readings slightly above zero are often normal. Sensors may read up to +1 bar positive pressure during normal operation.
- If in doubt, you may remove the sensor and reinstall it to see if the behavior changes.
- You may test the sensor in the lab. The sensor should read zero in pure water.

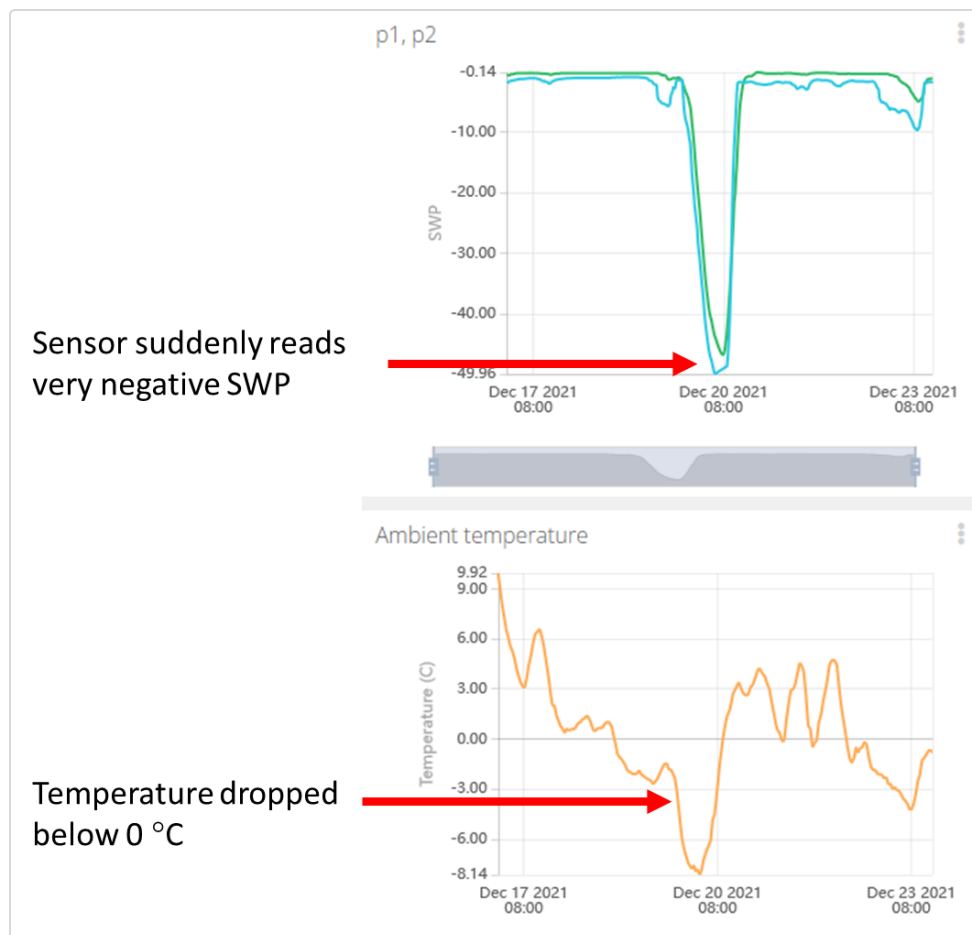
## Below zero temperatures

- Sensor suddenly reads very negative SWP when temperature drops below 0 °C.

- Sensors will behave erratically when exposed to temperatures below freezing. Specifically, at temperatures below 0 °C the water inside the installation site will freeze and the water potential of ice is lower than that of water. The measurement will be inaccurate.

- Sensors exposed to temperature below 0 °C will behave erratically and if the temperature is low enough (usually -5 °C) the sensor can freeze and break.
- If exposure is brief, the sensor may work properly afterwards. Longer exposure or colder temperatures will eventually freeze the probe and break it.
- Recommend removing the sensors during winter in places that routinely go below 0 °C. to avoid breakage.

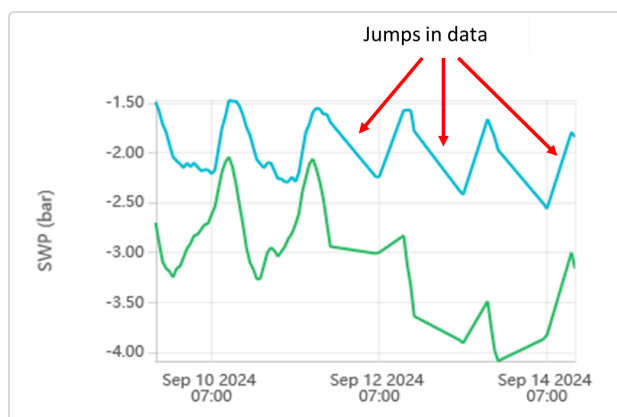
## Data is choppy or completely missing (FloraPulse Datalogger)

- Choppy or missing data from FloraPulse datalogger.

- If data is missing, it's usually due to the datalogger (not the sensors). There are three main causes: low battery, poor cellular signal, and broken hardware.
- [This video](#) goes over testing the various functions of the datalogger, including testing for signal and battery.

- Low battery: the dataloggers upload less frequently to save power. There are data gaps.
- Poor cellular reception: the dataloggers keep trying and failing to upload due to a problem with cellular reception. There are data gaps.
- No data: If there is zero data, the datalogger itself may also be broken due to physical damage or water damage.

- Low battery: ensure the solar panel faces up and gets enough sunlight. If this doesn't fix the issue, then you may need to replace the battery, or (unlikely) the solar panel.
  - Battery voltage should be greater than 3.6 V for adequate function.
  - The solar panel wires should output a voltage greater than 5V when in sunlight. The 'charging' LED should turn on in the datalogger PCB.
  - Older versions of our solar panels tend to yellow over time and lose efficiency – this could be the culprit – we can sell you an improved panel with more longevity.
  - SD card – our older logger versions sometimes drain the battery because of a bug in writing to the SD card. Remove the SD card if the battery is draining too quickly.
- Poor cellular reception: this problem can be difficult to solve. You can try a few things.
