FloraPulse

Sensor troubleshooting

February 5-6, 2024

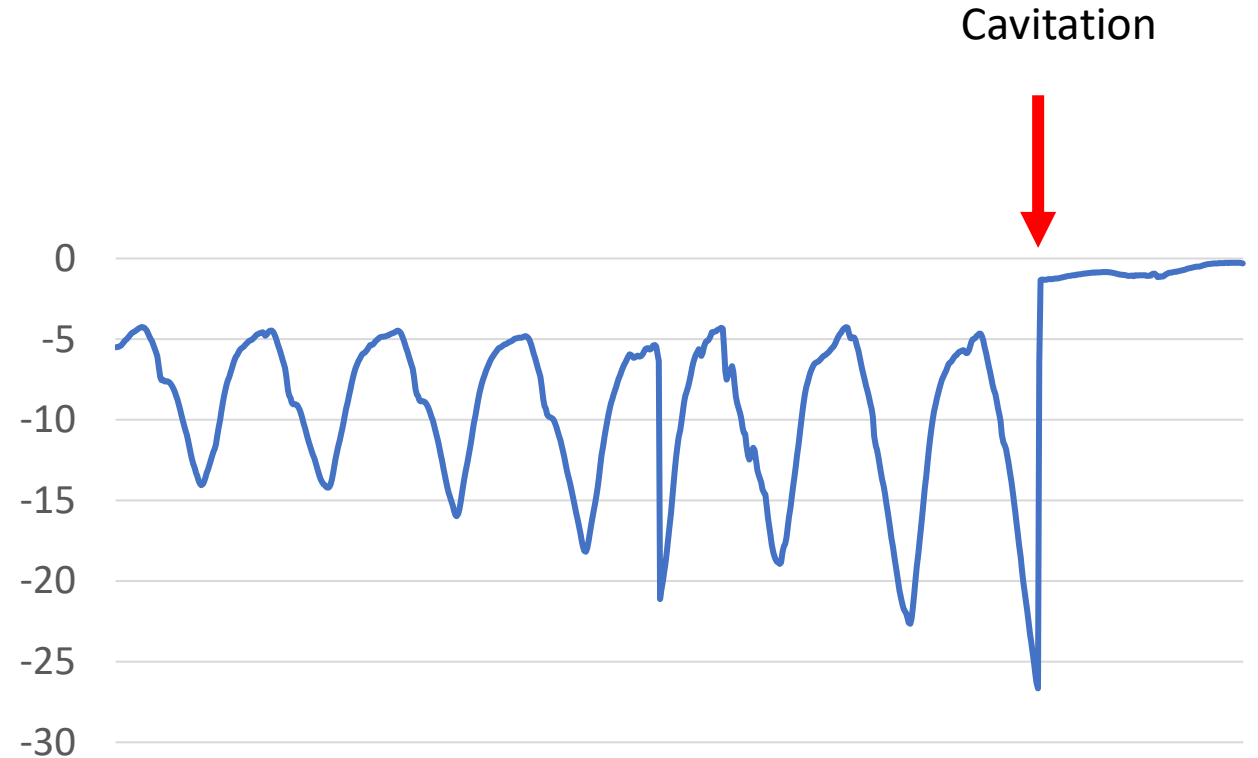
- Problem: sensor went to zero suddenly and isn't responding.
- Cause: sensor cavitated. Cavitation happens when the WP drops too low and the sensor membrane cannot hold the tension. The water inside the probe 'breaks' and the sensor will suddenly read zero.
- Or happens due to a defect in the membrane (the membrane broke).
- Shouldn't happen until the sensor goes below -35 bars.
- Solution: Refilling the sensor may bring it back to life. If plan to refill, keep sensor wet in the meantime.

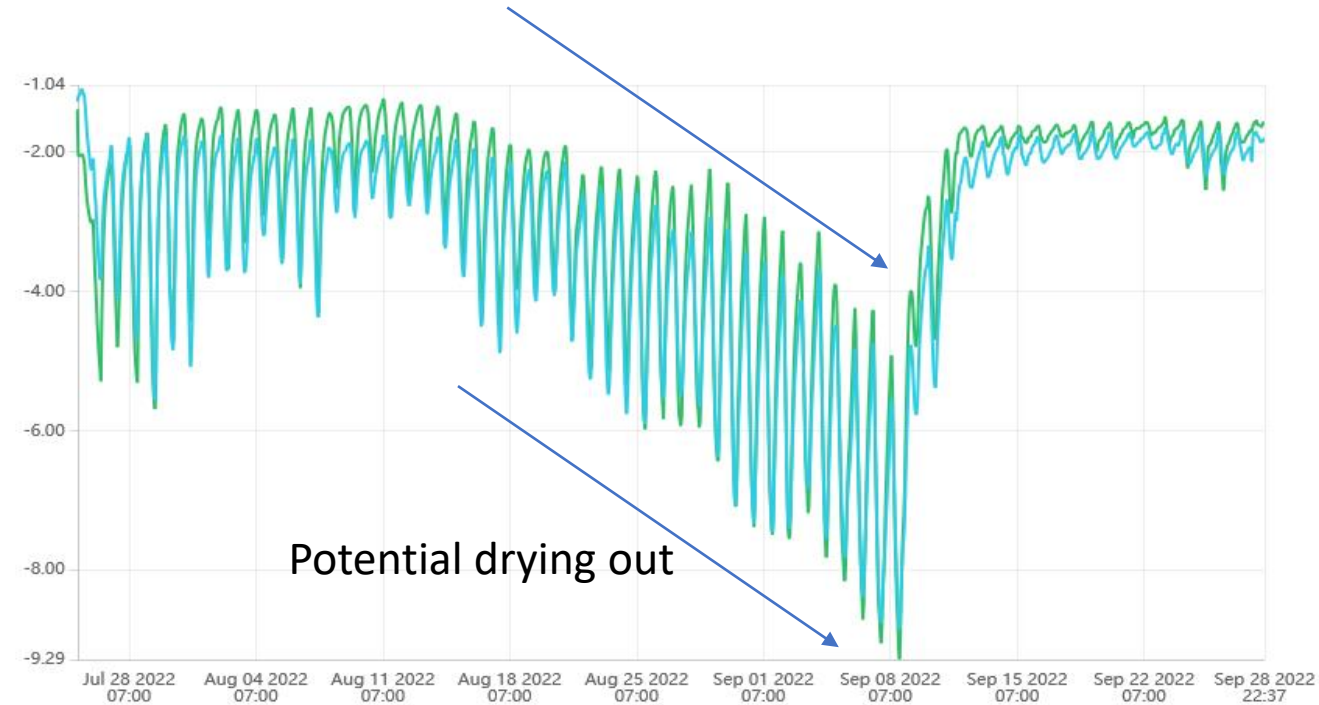
Dry out

- Problem: sensor reads much lower SWP values than expected. Both predawn and midday SWP are too low.
- Cause: could be caused by a water leak from the sensor installation site, causing the sensor to dry out and read drier.
- Solution: try adding more grease around the sensor sleeve to block any leaks.

Sensor drying out looks like this, but the sensor keeps getting consistently drier without a good explanation.

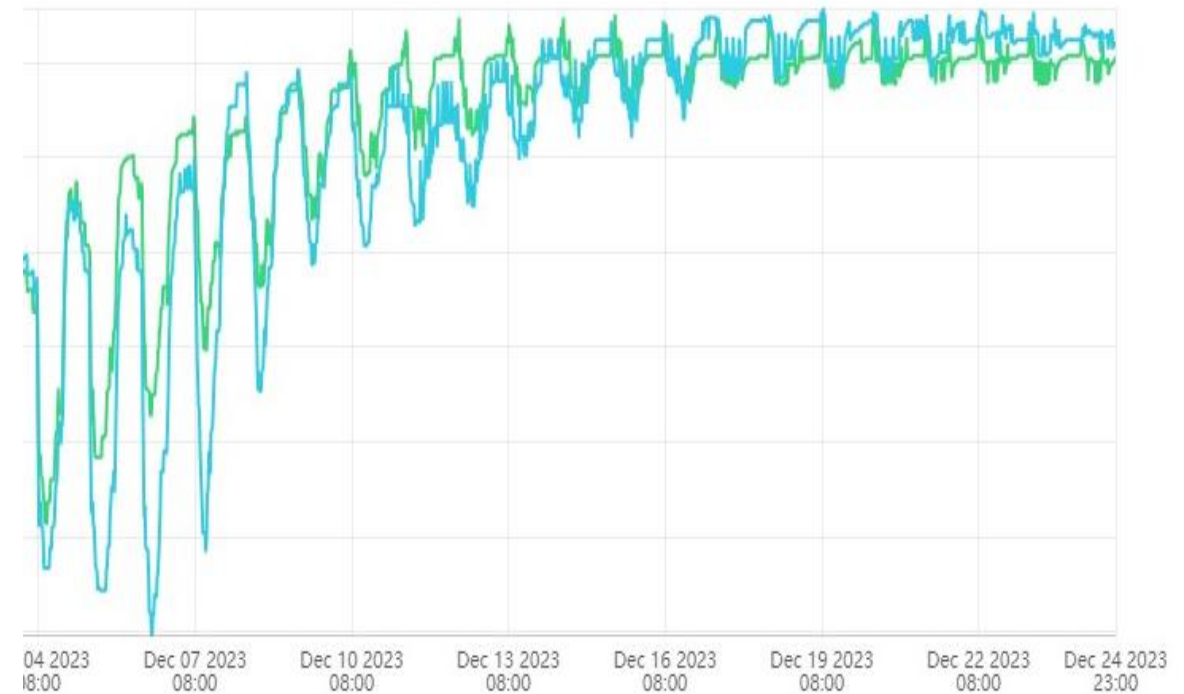
Shrinking of signal

- Problem: sensor readout shrinks so there is very small fluctuation in each daily cycle.
- Cause 1: poor connection with xylem due to wounding response.
- Cause 2: poor connection with xylem because wound closed over time.
- Solutions: this behavior may be due to the specific crop (i.e. walnut does this every time). Try re-installing and seeing if it happens again.
- Sensor may also be installed in 'dying' area of xylem. Reinstall in a different site.

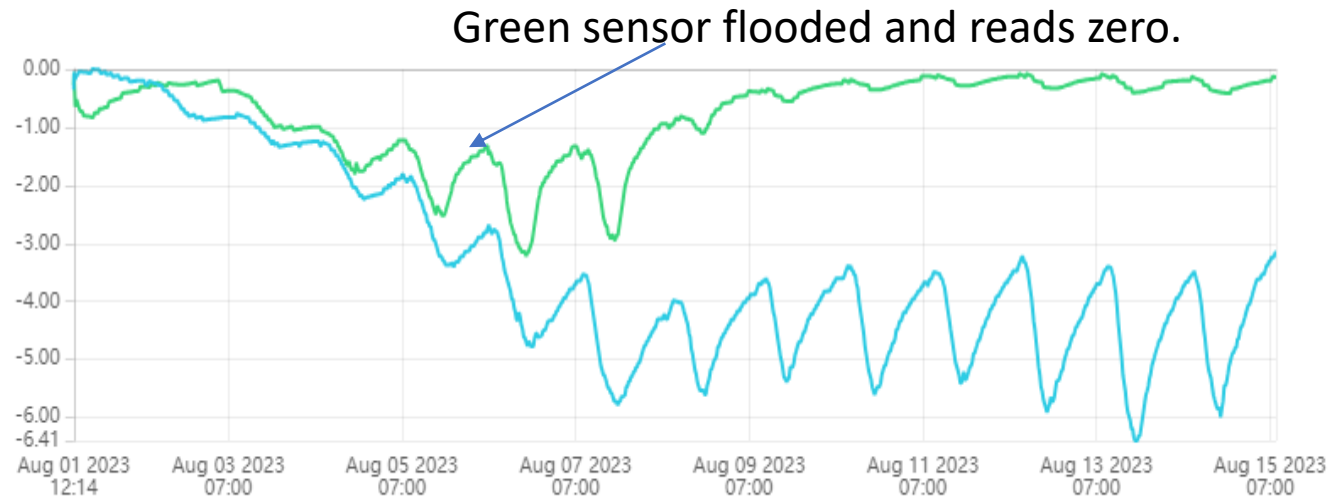
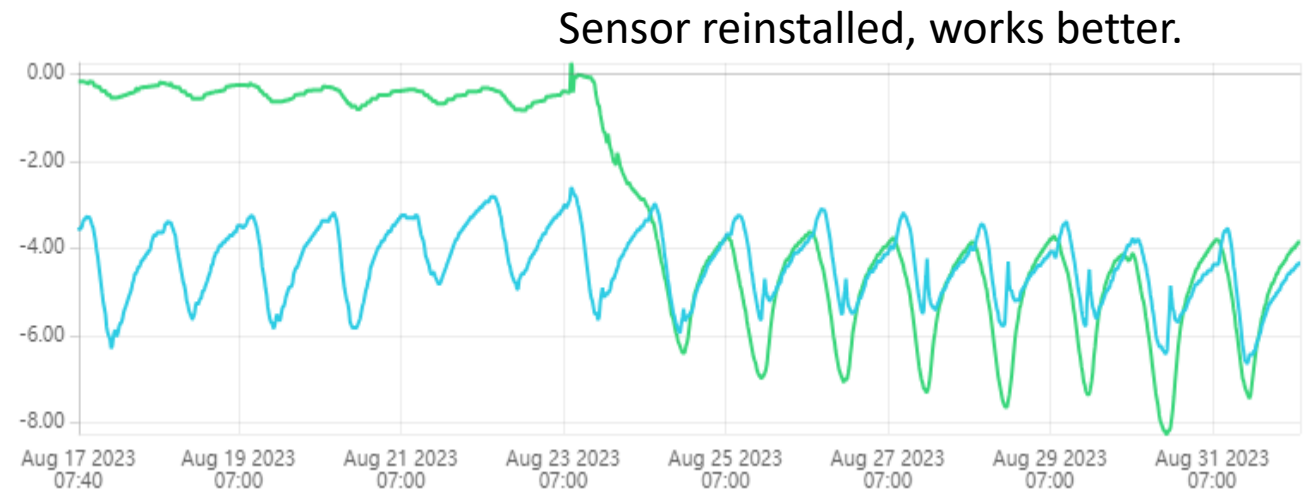
Flooding of sensor

- Problem: The sensor goes to zero and stays there.
- Cause: Likely wounding response is blocking sensor. Or installed in 'dead zone' of xylem.
- Solution: Try re-installing sensor.
- Some crops flood sensor immediately and cannot be measured for long: pecan, walnut and avocado.
- Some crops flood sensor randomly: pistachio, some citrus.

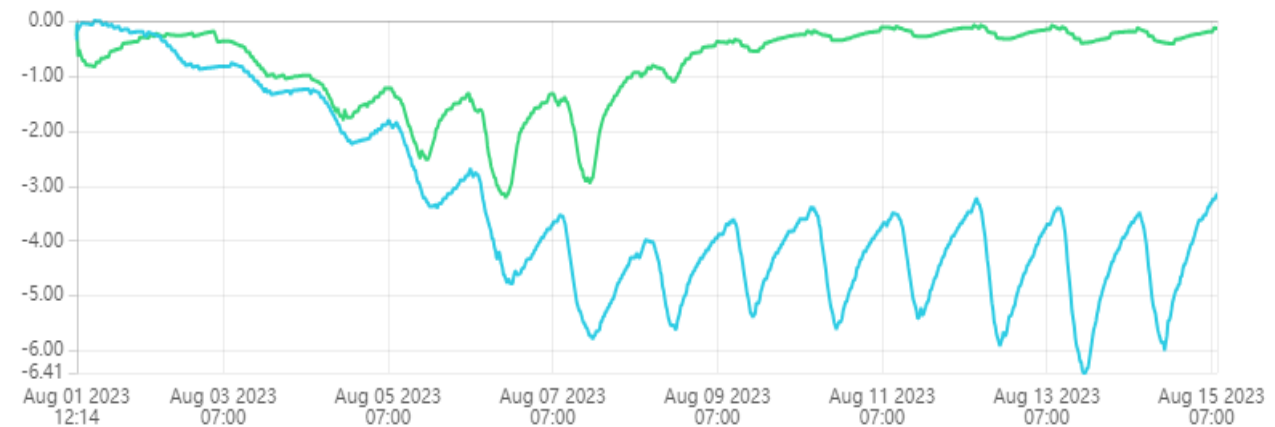
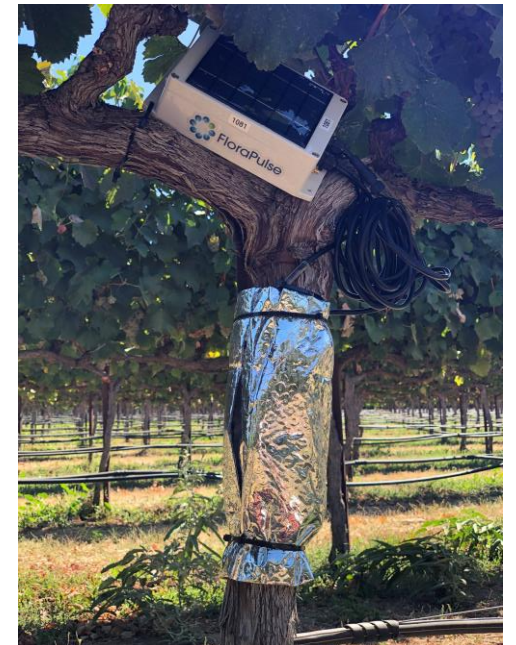
Wetting of sensor from outside

- Similar behavior to sensor flooding. The sensor goes to zero and stays there, but right after a rain/wetting event.
- Cause: water stuck inside the insulation is wetting the trunk for multiple days and getting to the sensor install site.
- Solution: the sensor bubble wrap insulation should be attached somewhat loosely so that excess moisture can evaporate. Especially important in wet climates.
- Might need to ignore SWP data right after a big rain storm, until excess water dries out.
- New small probe may be less affected by outside rain due to use of better sealant (still under testing).

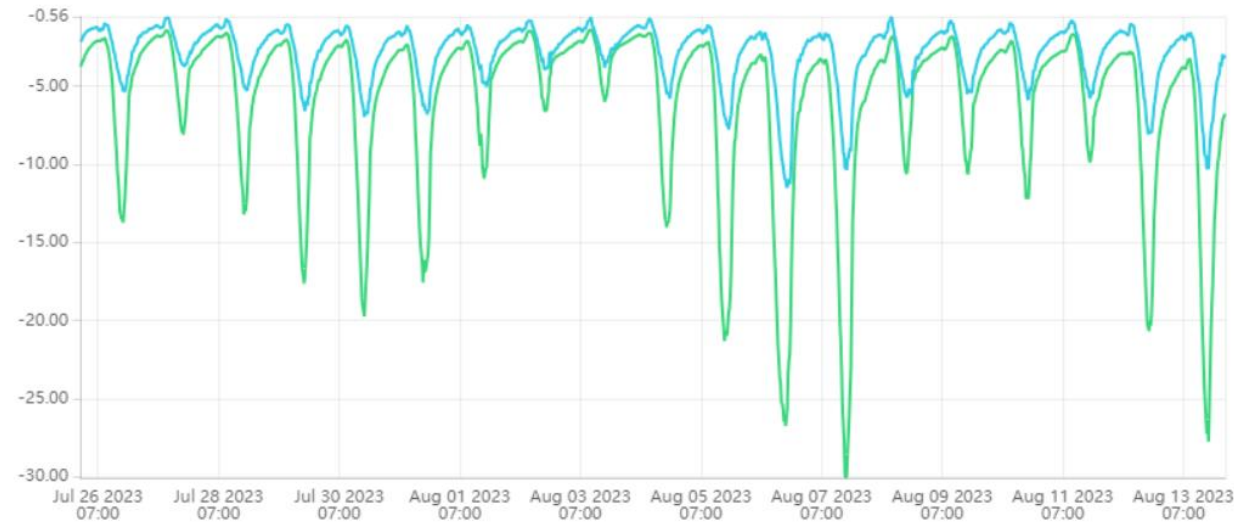
Psychometric spikes

- Reading WP is extremely difficult because tiny temperature differences cause huge errors. Usually not a problem with FloraPulse, except when there's a gap between the sensor and xylem.
- In the field, this shows up as reasonable SWP values when temperature isn't changing much (at night), but very negative SWP measurements during the midday.
- Cause: bubbles in the mating clay, sensor disconnected because moved/hit, extremely hot days with poor insulation. More likely in very hot climates.
- Solution: recommend re-installing sensor.

Grape install. Green sensor reads unrealistically low SWP during HOT times.

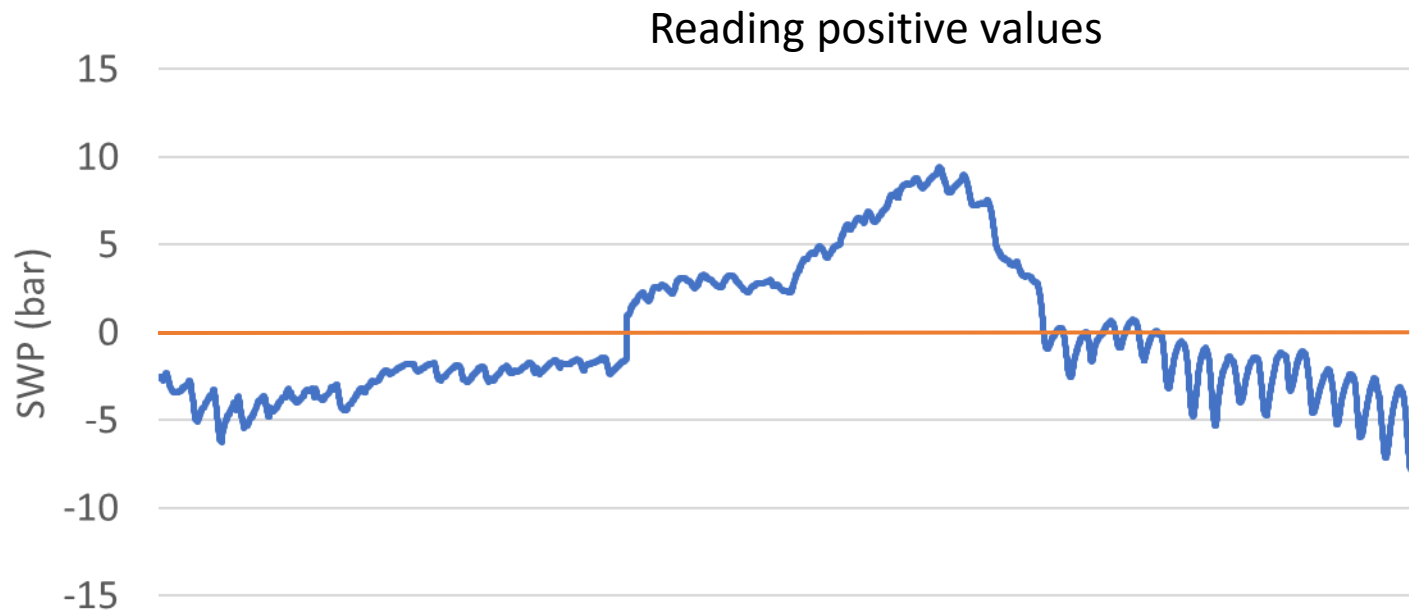
Wounding response spikes + positive values

- Pressure on the chip can cause it to read positive values temporarily. This often happens right after a rain event when the xylem expands with water and presses on the chip.
- Recommend ignoring the data if it is temporary. Otherwise remove, test and reinstall the sensor.

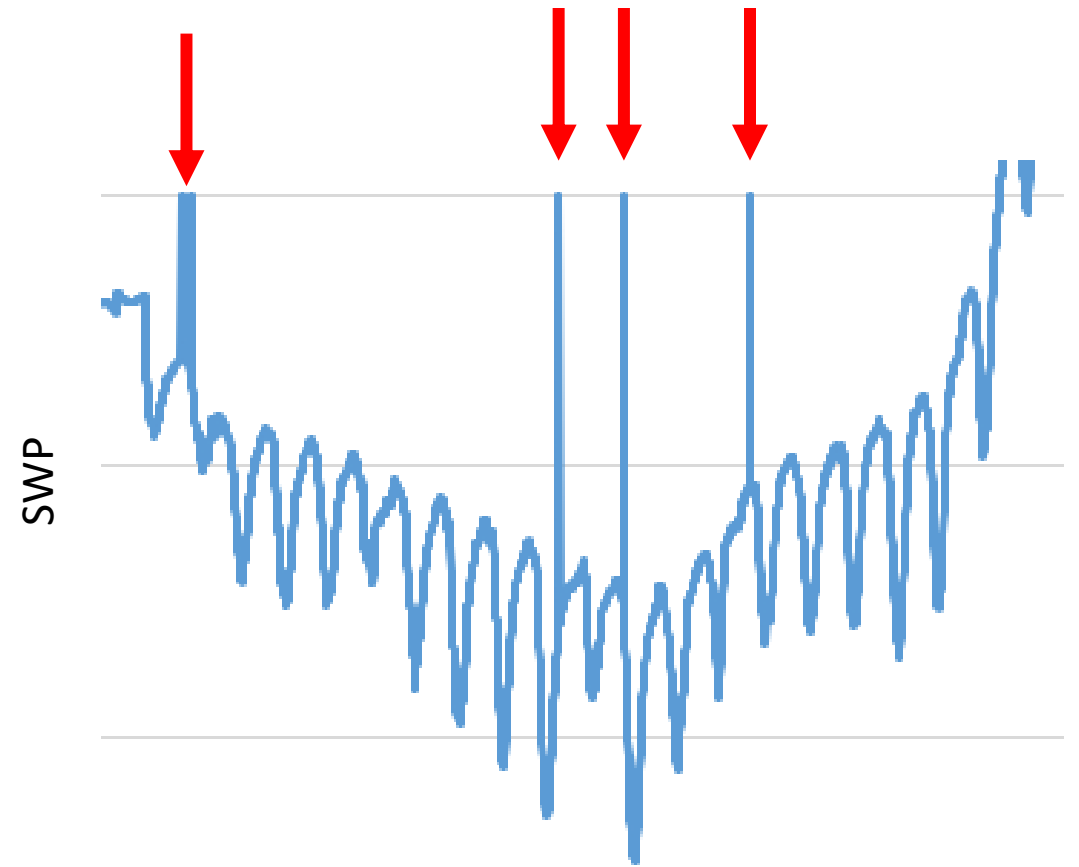
Random noise

- Sensors sometimes show random 'upward' spikes in the reading. It's unclear what causes this, but it may be due to the tree pressing on the sensor and stressing the chip.
- Recommend just ignoring them.
- The new smaller probe may be less susceptible because the probe sits completely inside the sleeve and isn't pressed on by the tree.

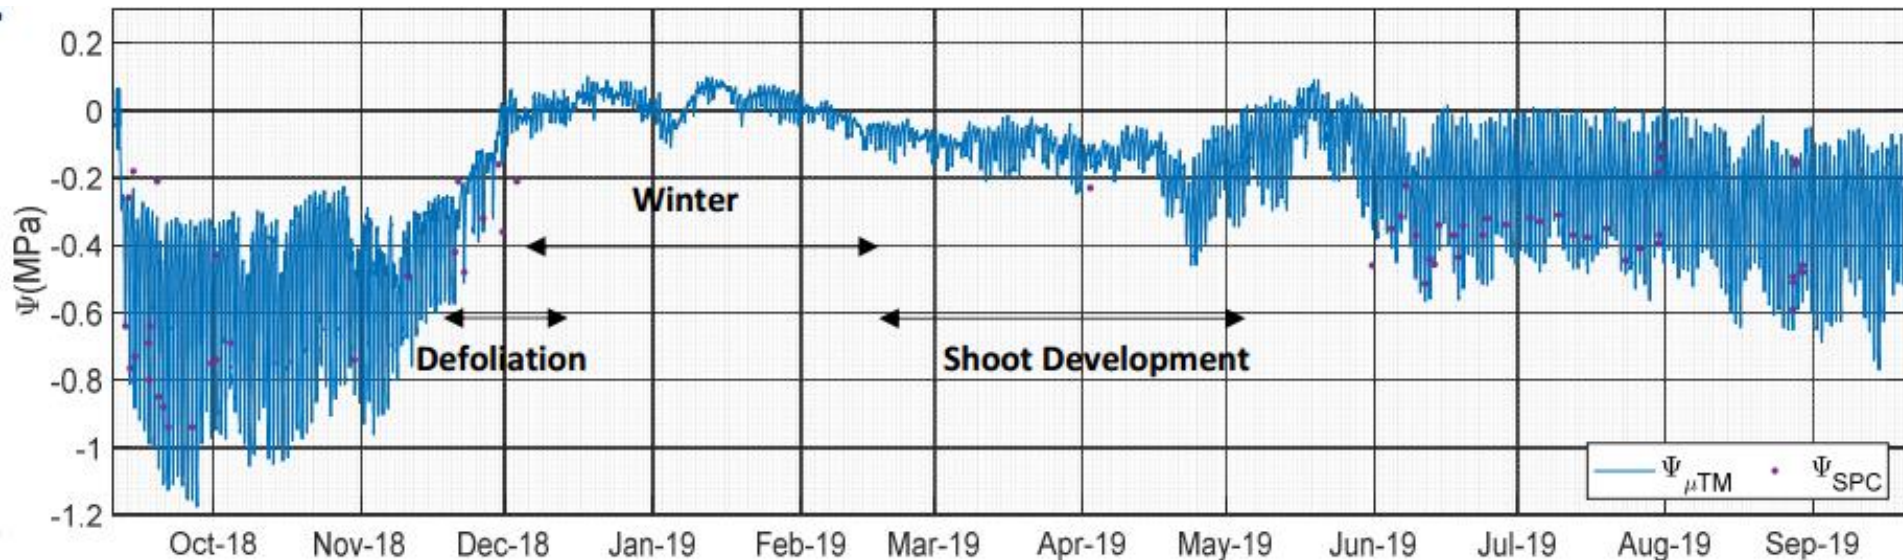
1 year measurement in cabernet grapes

- Many crops go dormant during the winter and the measured water potential will go to zero, or show some 'noise' near zero.
- The measured water potential may go slightly above zero (+1 or +2 bars max). This is normal.
- Data during dormancy is not particularly useful and may be dominated by noise.
- Recommend sensor re-install after winter for best accuracy. Depending on the crop, sensors will read wetter values if left installed over the winter (due to wound closure).

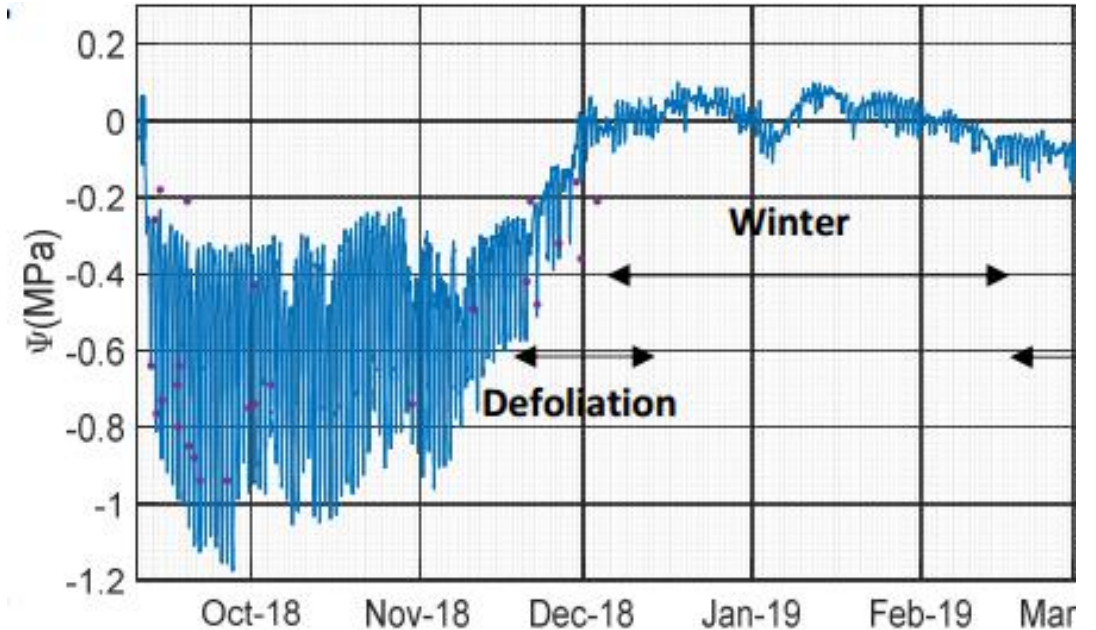
Slightly positive values

- Normal to have sensor sometimes read above zero, up to +1 or +2 bars.
- Cause 1: be due to electrical noise (sensor inaccuracy).
- Cause 2: In some crops, there is actually positive pressure in the xylem at times (i.e. grape during leaf out) and the sensor is reading this.
- Cause 3: The solutes from the tree xylem/elsewhere got into the sensor water and cause readings above zero due to osmotic pressure.
- If in doubt, you may remove the sensor and reinstall it. Or test it in the lab. The sensor should go back to zero in pure water.

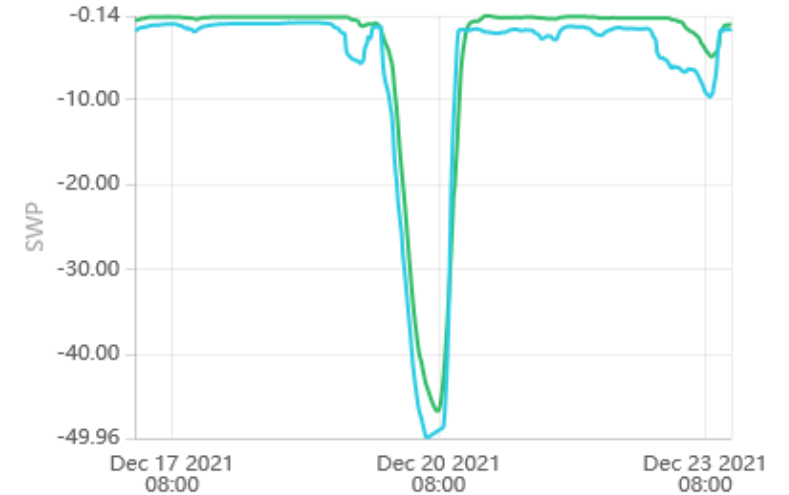
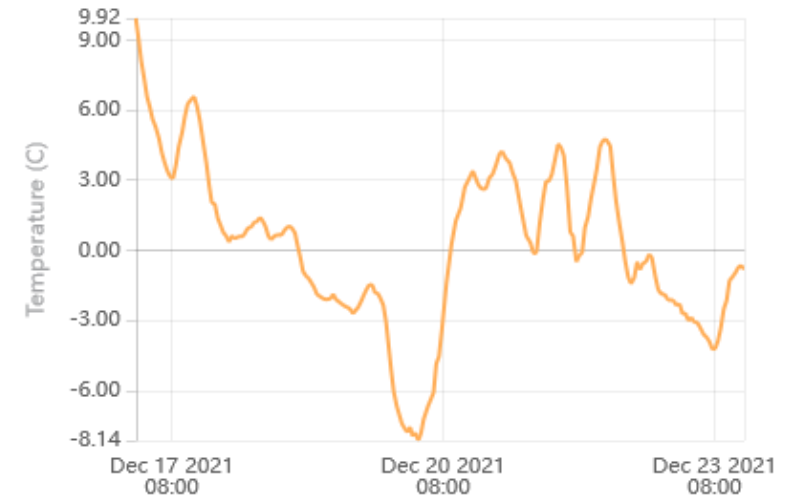
Below zero temperatures

- Sensors will behave erratically when exposed to below freezing temperatures.
- If the exposure is brief, the sensor may work properly afterwards.
- Longer exposure or colder temperatures will eventually freeze the probe and break it.
